Residential New Construction Program

Insulation installation and canned foam top plate gaskets have the potential for large impacts on energy savings and incentives in the RNC Program. This technical bulletin covers some frequently overlooked items that raters should check when inspecting insulation and canned foam top plate gasket installation.

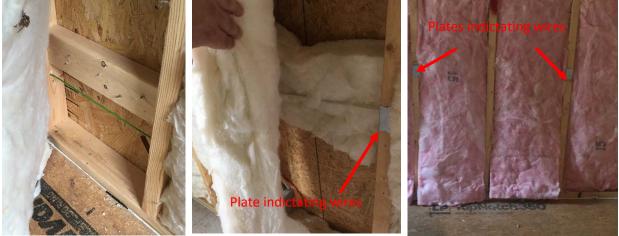
- 1. Electrical wires, Termite Systems, and 2x4 obstructions: Areas approximately 1' from the bottom plate tend to have termite systems or 2x4 obstructions. In addition, electrical wires can easily be found by looking for metal plates on studs. Insulation should be cut to fit around these obstructions to comply with RESNET's grade I definition. For a video description on RESNET's grading definitions, follow this link.
- 2. **Rolled or tucked batts:** Inspect the top and bottom of wall cavities. Often, insulators roll or fold insulation into the bottom or top of wall cavities instead of trimming insulation to fit cavities properly.
- 3. **Overfilled cavities:** To save time, insulators will place small pieces of batts behind wires and place a full batt over top of the wire. This does not constitute grade I installation and causes compressions and overfilling.

An example of termite systems and a 2x4 obstruction

An example of an overfilled cavity with a plate highlighting the wire location

An example of batts not cut to fit wall cavities with plates showing wire locations
