## **Technical Bulletin: Diagnosing Blower Door Problems**

Residential New Construction Program

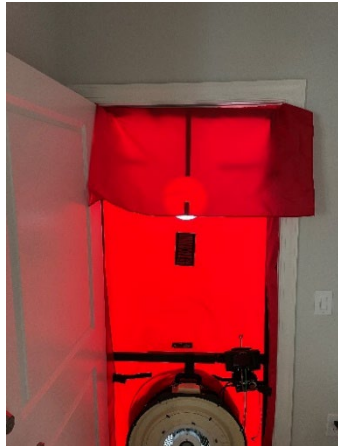
Blower door has a gap at the top right corner.  
Adjust door to be snug with framing.

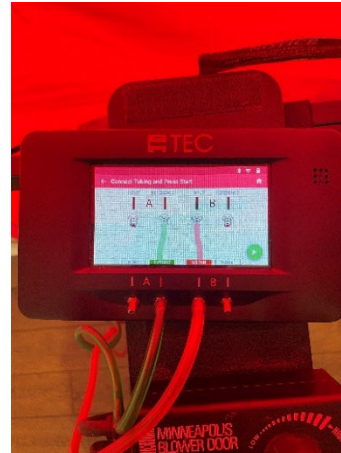
The DG1000 has a tubing assistant feature, this can be used to ensure hoses are connected correctly.

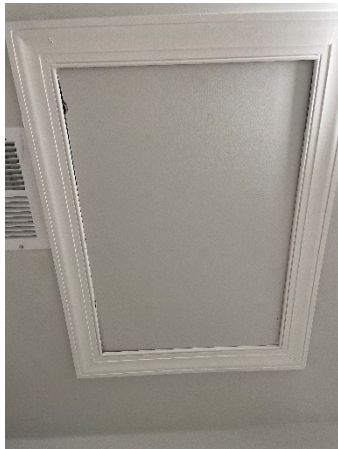
Attic scuttle is not aligned with the framing leaving gaps.

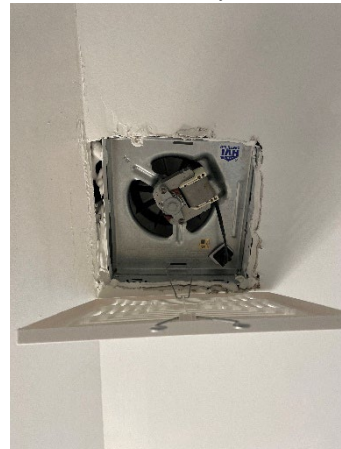
Bath fan exhaust is not completely caulked to the drywall.

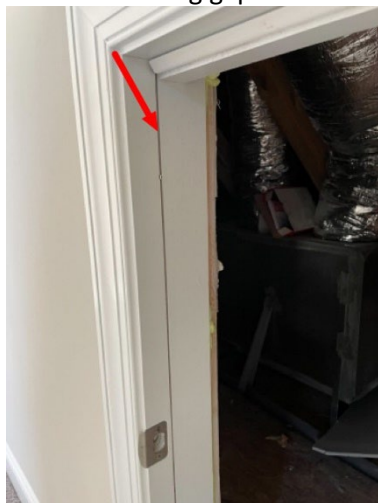
Attic scuttle door is missing weatherstripping on the sides.

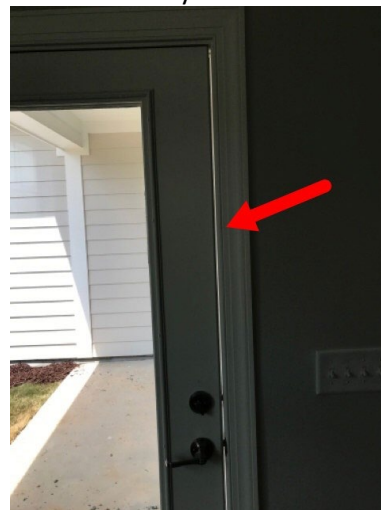
Rear door does not have weatherstripping.
