## Technical Bulletin: Rater Photo Library

### Residential New Construction Program

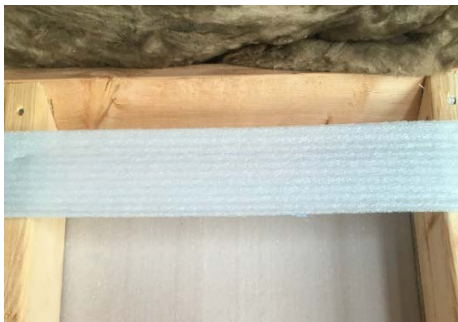
Bad example

#### **Issue:** Sill seal not in contact with top plates

**Problem:** Sill seal needs a top plate to gasket against and prevent air leakage.

**Solution:** Place a new top plate in the wall cavity so the sill seal can prevent air leakage.

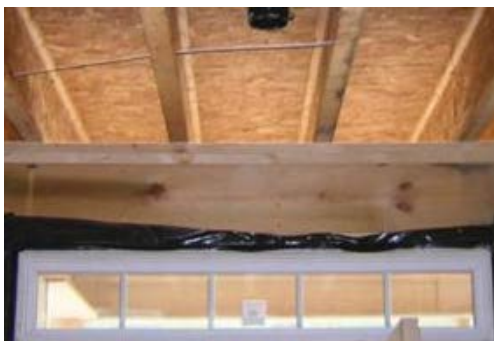
Bad example

#### **Issue:** Rim joist air barriers missing

**Problem:** Missing rim joists prevent air leaking into floor cavities and should be present on all floors connecting to unconditioned spaces

**Solution:** Install air barriers and seal around the perimeter and penetrations.

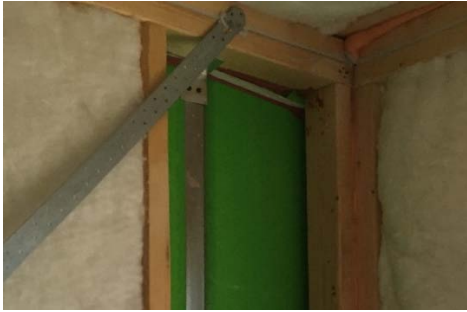
Bad example

#### **Issue:** Corner blocking in townhomes

**Problem:** Corners of common walls for townhomes are a large source of air leakage and need to be sealed.

**Solution:** Due to the difficulty in sealing corners in common walls, its best to block the corner and seal the blocking.
