Technical Bulletin: 2021 Common Rough Inspection Issues

Residential New Construction Program

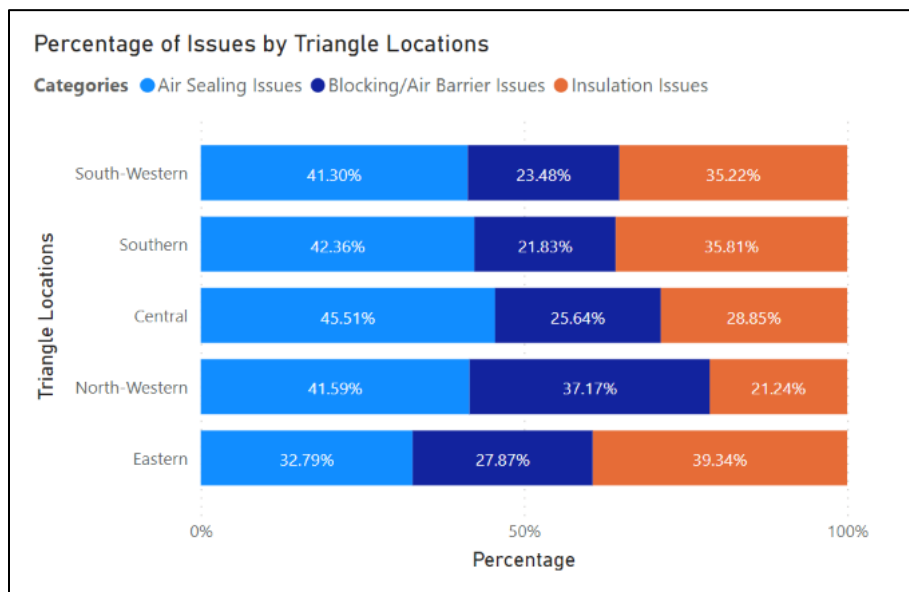
Percentage of issues by Triangle Location

Issue Category	Percentage for 2021	Compared to last year
Air Sealing Issues	42.2%	↑23%
Blocking/Air Barrier Issues	24.9%	↑1.1%
Insulation Issues	32.9%	↓6.9%

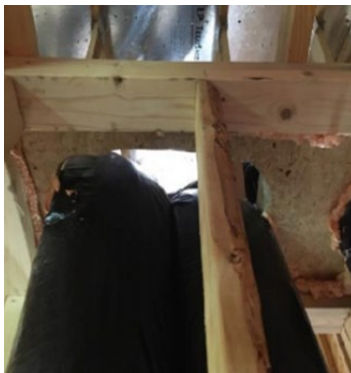
An unsealed chase.

- Chases – Chases are often not fully sealed at the top due to penetrations or an improperly sized air barrier. Air barriers should be picture framed. If a gap is larger than 1”, remember recommend adding more blocking followed by air sealing.
- Drywall to top plate air sealing – This aspect of air sealing is one of the largest factors to infiltration results and needs a quality install. On spray foam products, the bead should be

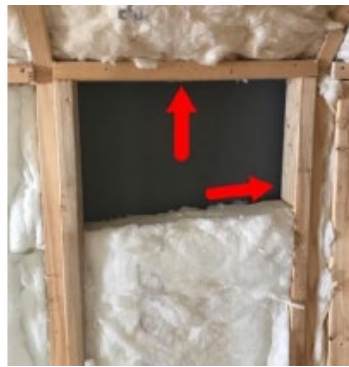
An unsealed kneewall.

- Kneewalls – T-ply should be installed with manufacturers specifications. Follow this link to see our technical bulletin on [Thermoply Installation](#).
- Common walls – Townhome core walls should be fully sealed around the entire perimeter. Remember to walk all core walls of a townhome to verify the corners, top plates, bottom plates, and rim joists are fully sealed.

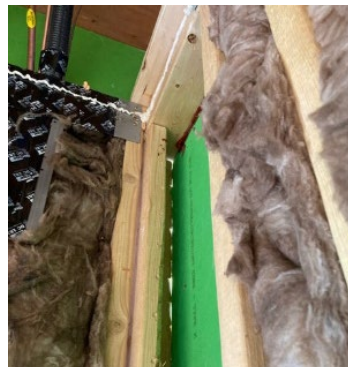
An unsealed common wall.

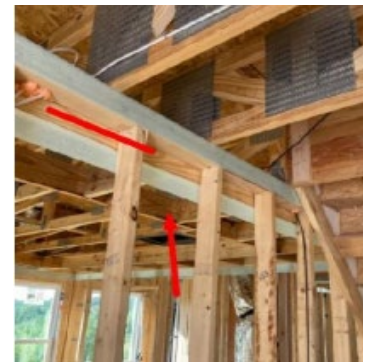
The framing of a dropped ceiling isn't sealed to top plates

- Dropped ceilings or soffits – Often, air barriers are missed in dropped ceiling due to complexity. Ensure any rim joist over dropped ceiling has blocking connecting the rim joist to drywall.
- Rim joists – Rim joists for kneewalls and garage floors always need air barriers that fully block the interstitial space between floors.
- Chases – Chases need a complete air barrier on exterior walls and tops.

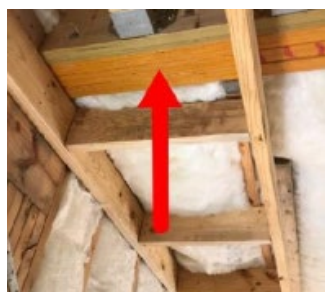
A knee wall rim joist in a dropped ceiling missing an air barrier.

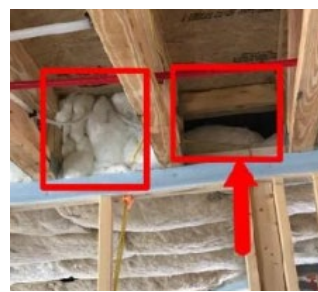
A kneewall rim joist missing blocking.

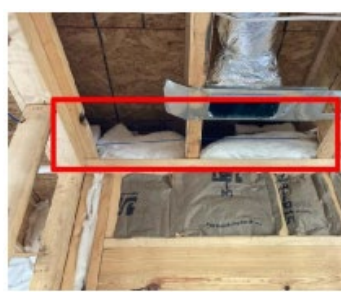
A garage floor rim joist missing blocking.

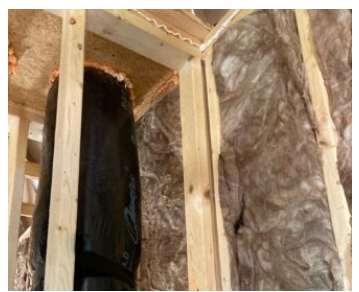
A chase on a wall backing unconditioned space missing a barrier.

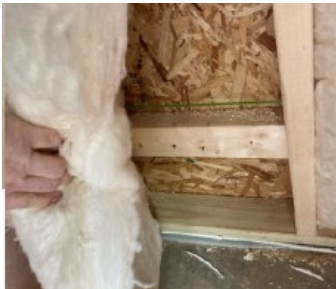
Insulation not split around wires and purlins.

- Insulation is not split around obstructions – All obstructions in walls have potential to compress insulation, resulting in poor performance. Remember to pull back insulation and check for obstructions. Insulators often try to hide imperfections during installation.
- Insulation has compression greater than $\frac{3}{4}$ " – General insulation compression due to improper sizing of batts is another common issue. Check the tops and bottoms of walls as insulation is often rolled into the cavity.
- Other insulation issues – While checking for advanced framed corners and intersections, take note of any that are missing insulation. These are missed or overlooked often.

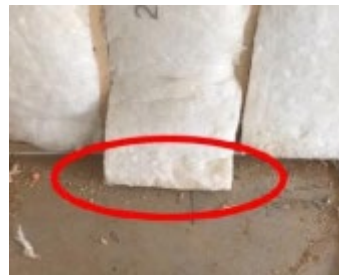
Insulation cut long and rolled at the bottom.

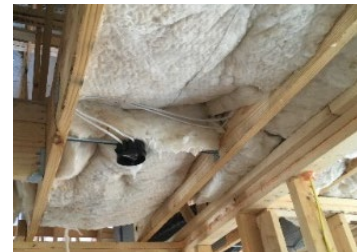
Ceiling insulation not making full contact with drywall.
