Technical Bulletin: Most Common Issues

Residential New Construction Program

Over the past year the RNC Program has compiled a list of the most common issues found at pre-drywall quality assurance inspections. This technical bulletin outlines those issues along with tips to address them during rater inspections.

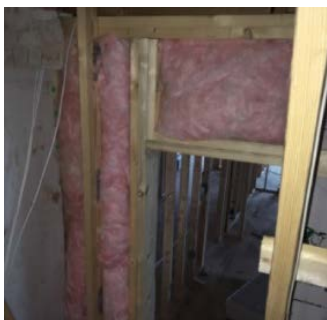
Kneewall missing an air barrier

- All wall cavities require six-sided encapsulation but remember to pay close attention to kneewalls as they separate attic and conditioned space.
- Air barriers are often missed in dropped ceilings due to complex home designs. Remember to move insulation aside to visually inspect for proper air barriers.
- The best air barriers are rigid air barriers such as Thermoply and wood. Cardboard is ineffective as an air barrier and is not recommended.

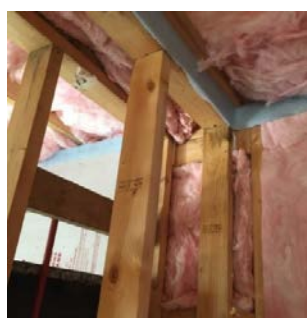
Double wall missing air barriers

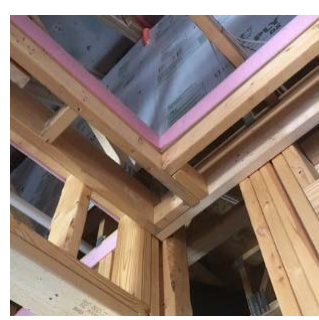
Dropped ceiling missing an air barrier at the top

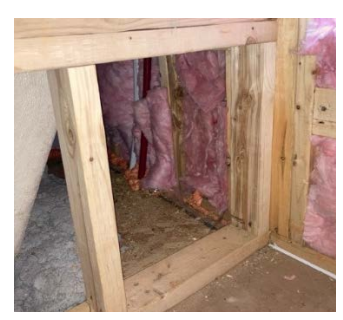
Tub missing an air barrier

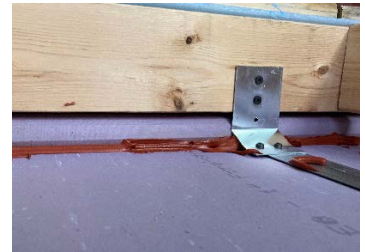
Core wall not sealed to top plates

- Townhome core walls are notorious for poor air sealing. When inspecting townhomes, remember the following.
 - Ensure each floor has core walls fully sealed at the top plates, bottom plates, and side studs.
 - Recommend that the builder tape exterior walls to the core walls before installing housewrap.
 - For difficult to seal locations, recommend adding blocking to fill gaps and air seal around the blocking.
- Sill seal for top plate gasketing should be fastened above each stud (12"-16"). It is also best practice to cut sill seal around corners with limited overlapping areas.
